Challenge

Goals

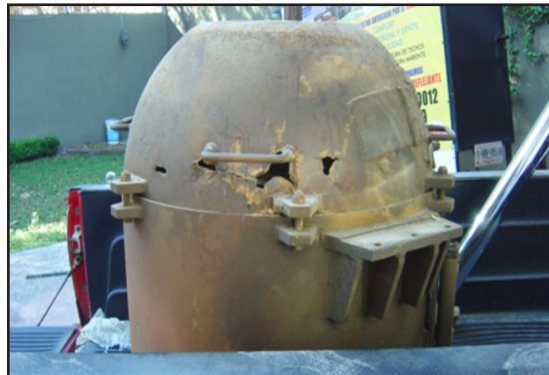
The high temperature caustic mix in mills were abrading and damaging the fiberglass and rubber linings from the OEM. Additionally, the lining adhesive disbonded and delamination occurred. The metal substrate corroded.

Worn mill after failure of rubber and fiberglass

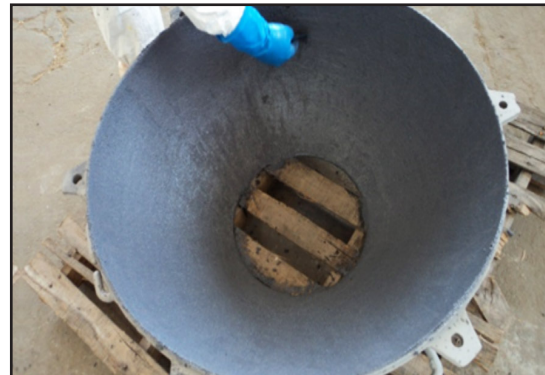
Application of ARC coatings

- Pressure wash and decontaminate surfaces
- Grit blasted to Sa 2.5 with 3 mil (75 µm) profile

1. Apply **ARC BX1*** in lower section
2. Apply **ARC BX2*** in upper section
3. Smooth out irregularities with **ARC 858**
4. Topcoat with **ARC 855** to reduce friction and protect against corrosion

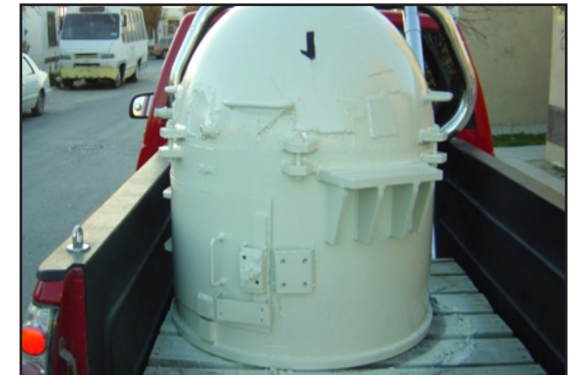
First mill after repair ready for delivery
