## Challenge

Previously applied coating had failed after 2 years, resulting in severe pitting and weld zone corrosion. Client was forced to replace 10% of floor plate at cost of €175K. 40% of floor experienced pitting corrosion up to 30% of plate thickness.

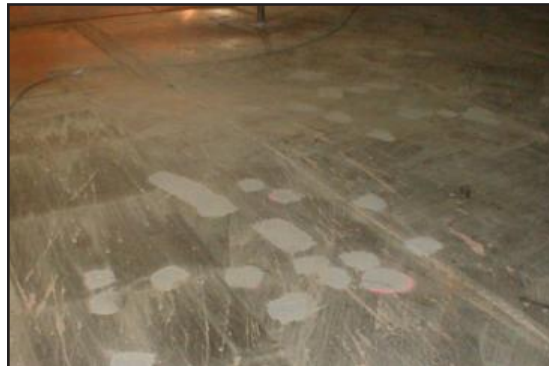
Prior failed lining and corrosive effects of seawater.

Severe pitting corrosion found under the existing coating repaired with ARC 858

1. Corroded and pitted areas were brought back to 100% of original thickness with **ARC 858**
2. Use **ARC S1PW** to stripe coat weld seams, striker plates, and transition points
3. Apply 2 coats of **ARC S1PW** via heated plural component spray equipment to a total DFT of 20 mils (500 µm)

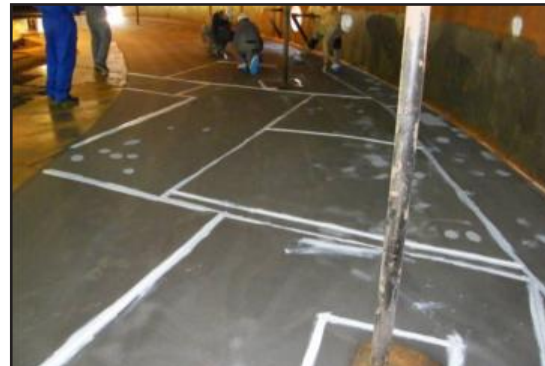
Application of the stripe coat to all weld seams

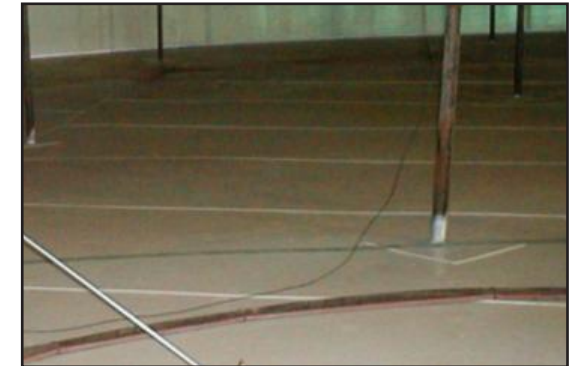
Final inspection of the ARC lining to ensure a continuous pinhole free protective lining
