Challenge

Issue

Corrosion of valve due to failed rubber lining led to leaks and environmental fines totaling >\$200K.

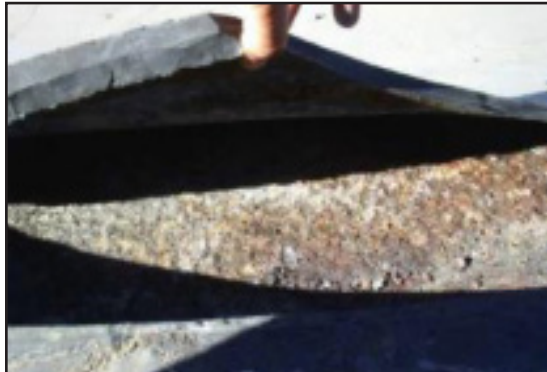
15% H₂SO₄ vapors at 120°F (50°C), under vacuum of 1 bar (14.5 psi), attacked rubber lining.

Delaminated rubber liner with corrosion underneath

- Remove rubber lining by UHPWB at 40 kpsi (2,600 bar)
- Grit blast to Sa 2.5 with 3 mil (75 μm) angular profile

1. **ARC 858** used to rebuild corroded and pitted valve disc and body
2. Apply **ARC BX2*** for abrasion resistance of valve disc
3. Topcoat valve body with **ARC S4+** for chemical resistance

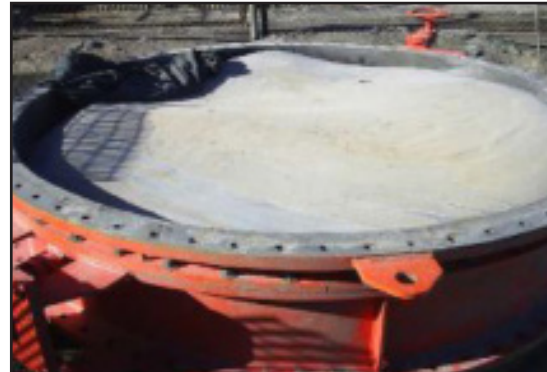
Disc before rubber removal
