Challenge

Severe corrosion of the Corten B steel chimney liner would require liner replacement if left unaddressed.

The flue gas chimney at wood and peat burning power plant

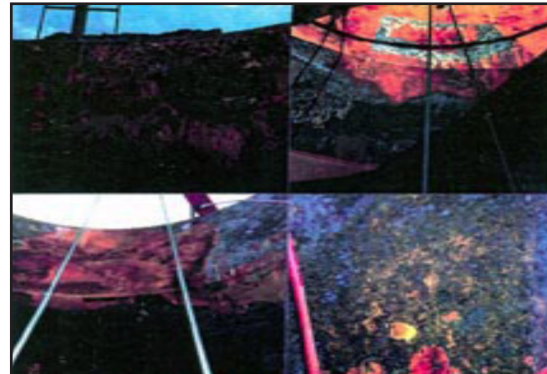
Flue gasses enter the chimney at 130°C (266°F). As it cools going up stack, it drops below dew point and acids condense on walls leading to extreme corrosion rate.

Severe corrosion in chimney due to condensing acid gases

- Decontaminate surfaces
- Grit blasted to near white metal with a 3 mil (75 µm) profile

1. Stripe coat of **ARC S7** applied to all weld seams by brush
2. Apply two coats of **ARC S7** by heated airless plural component spray with a total dft of 40 mils (1 mm)

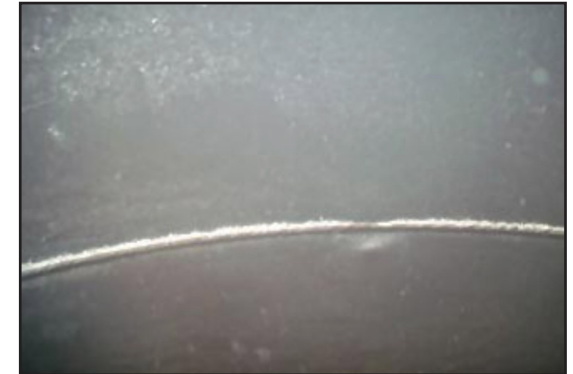
Inspections at 5 years and 10 years show the **ARC S7** lining in excellent condition.

ARC S7 lining still in excellent condition after 10 years of service
