Challenge

Issue

Failure of a rubber and tile lined chute caused leaks and unscheduled outages with lost production costs of >\$115K/per day.

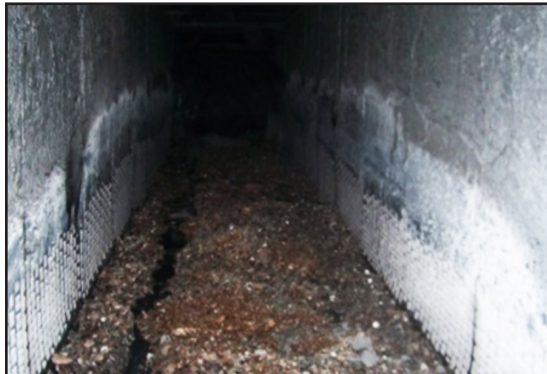
Seams in rubber lining exposed to highly abrasive slurry discharge cause rubber tears and delamination.

Discharge flume with damaged tile/rubber liners

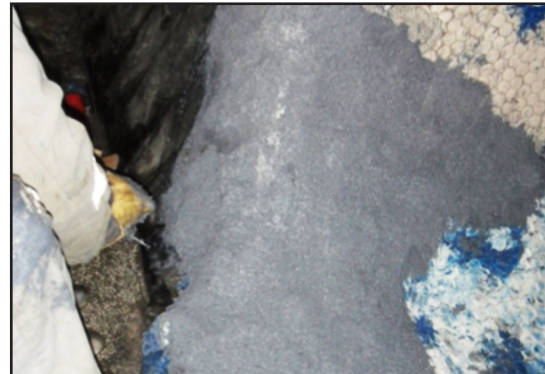
Applying ARC IBX1

- Apply **ARC IBX1** to prepared surfaces to mate up to damaged rubber and tile sections
- Use radiant heat lamps to accelerate cure to <24 hours

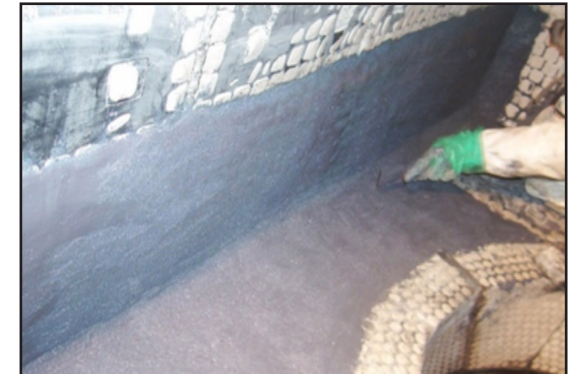
ARC coated surfaces
