## Challenge

After 20 years in service, corroded pump internals reduced flow and efficiency. Client sought options to high capitol replacement cost with long lead time.

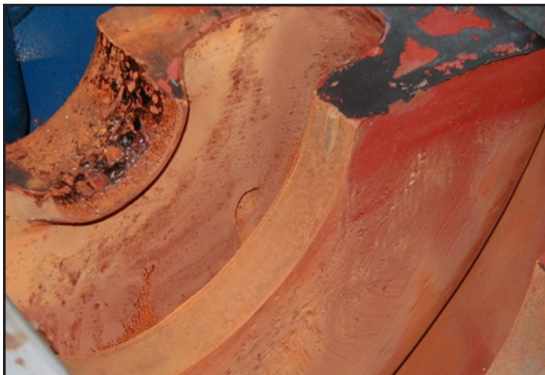
Corrosion and erosion from entrained solids degraded internal tolerances and increased frictional drag through hydraulic passages.

Eroded and corroded pump volute

- Decontaminate surfaces
- Grit blast to Sa 2.5 with 3 mil (75 µm) angular profile

1. Apply **ARC 858** to fare smooth and fill pitted surfaces rebuilding tolerances
2. Apply 2 coats of **ARC S2** @ 15 mils (375 µm) DFT per coat

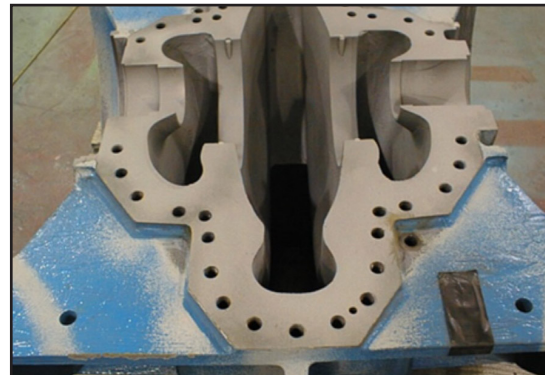
Surface after proper surface preparation

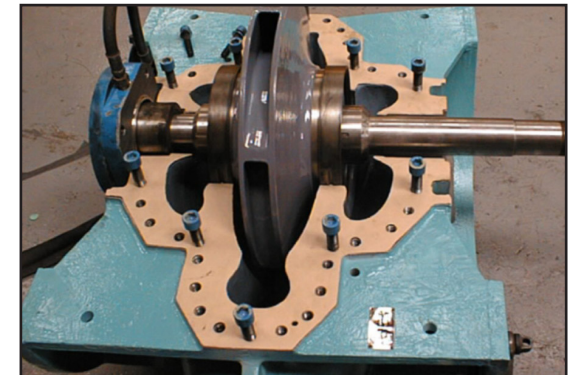
ARC-coated surfaces - casing and impeller

- Rebuilt pumps returned to 100% of BEP
- Lead time reduced from 30 weeks to 3 weeks
- ARC upgrade was <40% of replacement parts
- Used ARC to upgrade for 15 more pumps
