Fiberglass mat reinforced polyester lining cracked and delaminated from process floor in ClO₂ mixing room in bleach plant

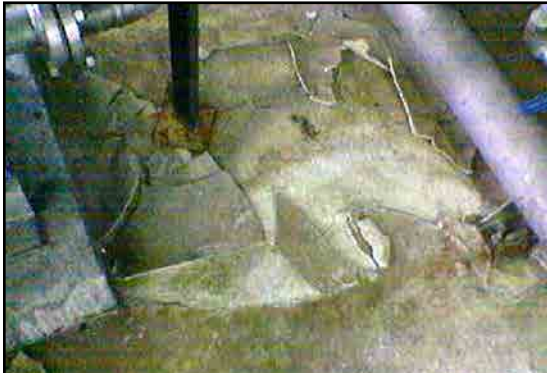
Spills of 15% ClO₂

Delaminated glass matt polyester

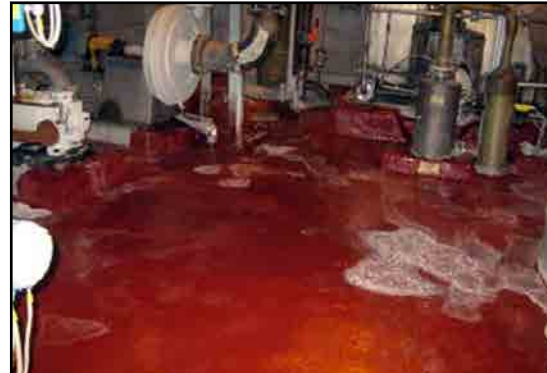
ARC NVE VC in service

- Damaged concrete re-pitched to drains at 2° slope using cementitious mortar
- **ARC NVE Primer** applied followed by two coats of **ARC NVE VC** at 15-20 mils (375-500 µm)/coat

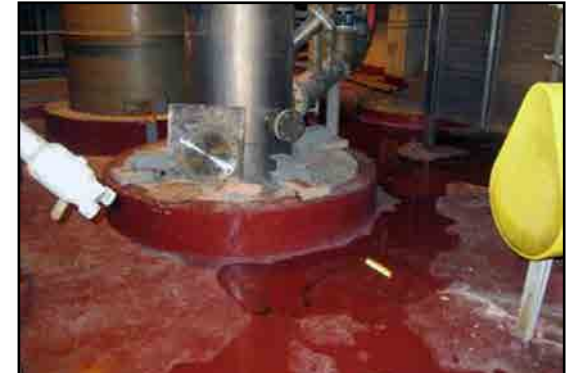
ARC NVE VC in service
