Issue

Rubber lined exhaust elbows clog up with gypsum and wear out in <6 months requiring unit shutdown to replace

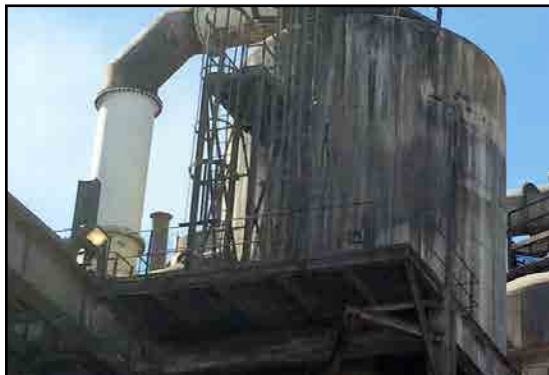
Flash cooler with exhauster

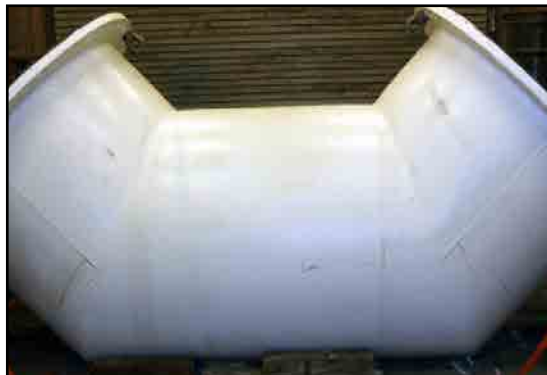
Carry over contains gypsum and highly corrosive phosphoric acid

Exhaust elbow in shop laydown

- Damaged rubber lining removed
- Grit blast to Sa 2.5 with 3 mil (75 µm) angular profile

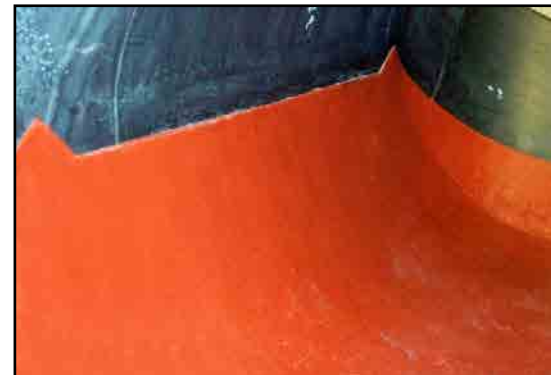
Repaired unit ready for install

- Apply **ARC T7 AR** to 240-360 mil (6-9 mm)
- Apply veil coat of **ARC T7 AR**
