Challenge

The polyurea lining in a clarifier peeled and wrapped around the rake arm, leading to total delamination.

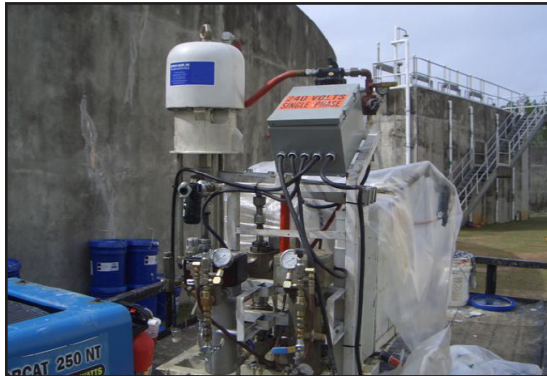
Heated plural component used to apply **ARC S1HB**

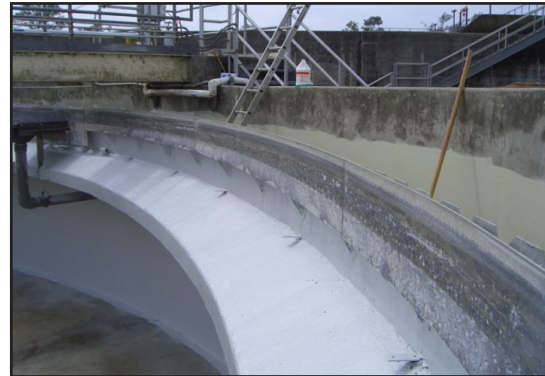
In the process of applying **ARC S1HB**

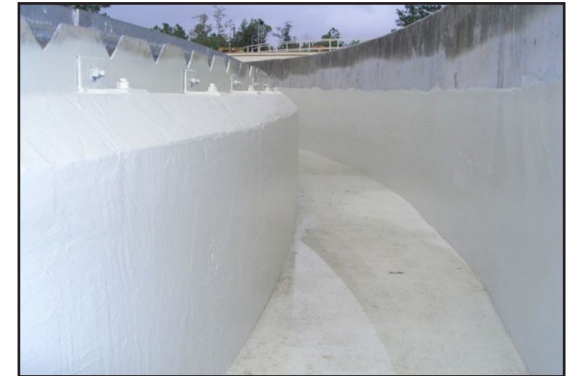
Final finish applied to clarifier
