## Challenge

### Issue

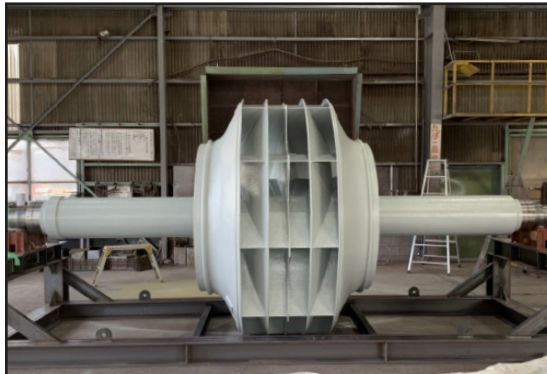
An unlined exhaust fan was exposed to corrosive flue gases with suspended erosive particulates. The fan sustained severe corrosion and erosion damage impacting balance and performance. Operating temperatures were <math><120^{\circ}\text{C}</math> (<math>250^{\circ}\text{F}</math>) with up to 4% suspended particulates in the form of fly ash. Client was required to shut down fan and hydro-wash fans every 8 – 10 weeks at a cost of \$10K per shutdown.

ID Fan in paint shop.

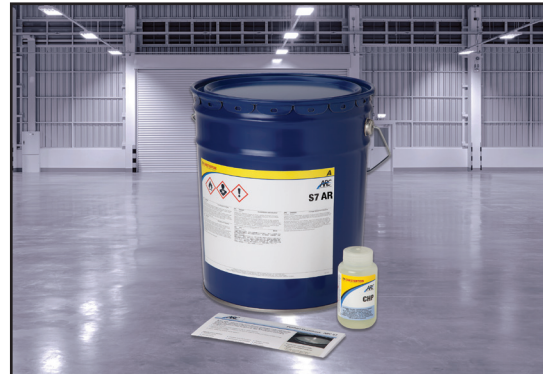
ARC S7 AR with CHP Catalyst.

ARC S7 AR was recommended due to its ability to resist high-temperatures and erosion.

Three coats of ARC S7 AR were applied to the fan vane tips to a total dry film thickness of 0.75 – 0.9 mm (30 – 35 mils). The balance of the fan received two coats to a total dry film thickness of 0.6 – 0.75 mm (25 – 30 mils).

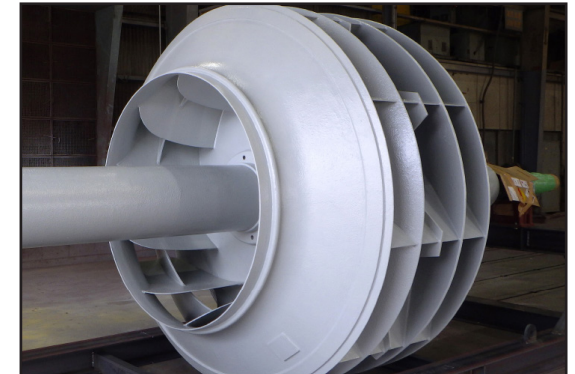
A fan that was coated in 2018 has shown <math><5\%</math> film thickness loss. Due to finish quality improvements, dust attachment was reduced so that shut down for hydro-wash have been cut to once every 24 weeks, saving >\$30K per year.

Dynamically balanced ARC S7 AR coated fan.

After coating cured, the fans were dynamically rebalanced.
