## Challenge

Severe cold wall corrosion attacked the high nickel alloy of the ducting. The plant was forced to make weld over-layment repairs and re-cladding every 6 – 8 months.

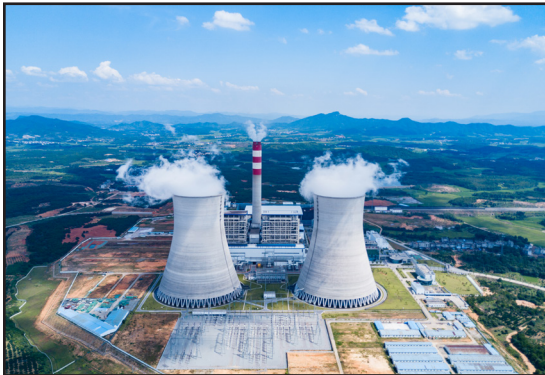
Fossil Power Plant.

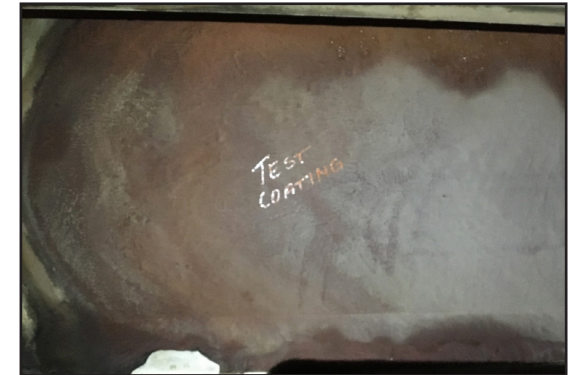
Trial area inspected after nine months exposure and found to be unaffected by exposure.

Test area of duct after nine months in service.
