Abrasion-induced failure of welds used to attach carbide inserts which resulted in reduced efficiency of the centrifuge.

To improve MTBF and maintain a higher level of dewatering over time.

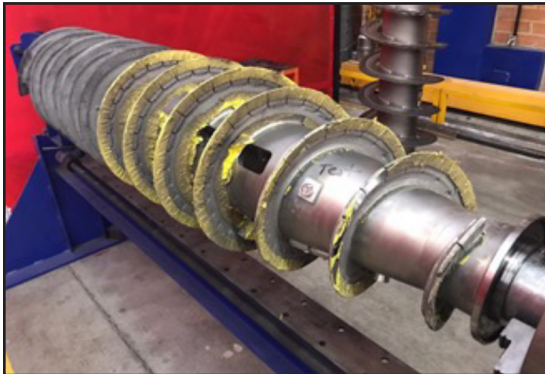
Erosive coal fines and acidic water attacked the welds which led to delamination of the carbide inserts.

Screw with tungsten carbide inserts being welded in place.

Remove all inserts and grit blast the surface to a 75  $\mu\text{m}$  (3+ mil) angular profile with a near-white surface cleanliness.
