Challenge

Issue

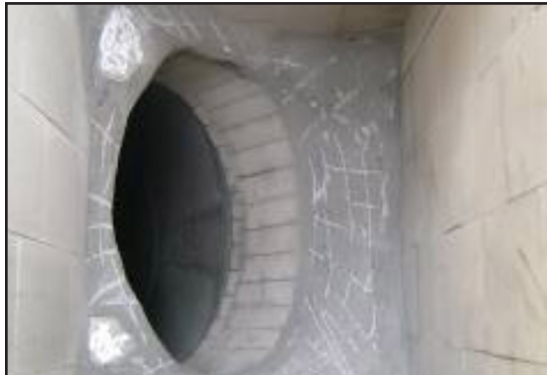
Ceramic tile lasts 4-6 months in this application before cracking and delamination occurs. Exposed steel wears through and requires weld repair before retiling. Previous patch material lasts <7 days.

Brittle fracture failure of ceramic tiles results from impact of coal up to 10 cm (4 inch) diameter. Acidic wash water corrodes steel.

Damage to existing ceramic tiles caused unscheduled shutdown and loss of production

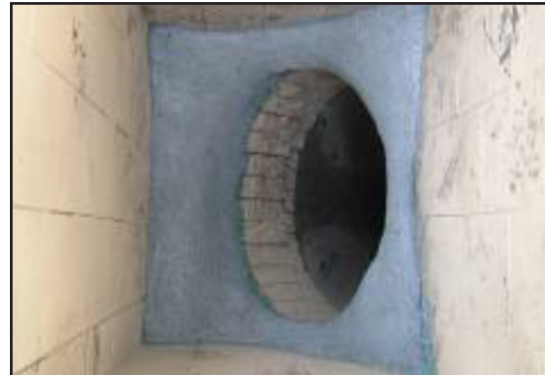
Installation of ARC MX5

- Grind down residual ceramic epoxy with power tool
- Decontaminate surface with solvent (MEK)
- Roughen with a rotary grinding tool

1. Apply **ARC MX5** at 120-200 mils (3-5 mm) to steel and cove up onto the ceramic tile
2. Apply **ARC S2** at 12 mils (300 µm)

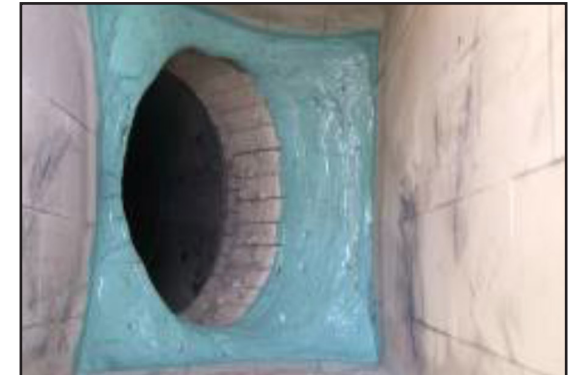
ARC MX5 with ARC S2 topcoat cures rapidly, allowing fast return to service of chute

- ARC repairs completed in 8 hours
- ARC solution provided over 6 months service before a touch-up was required
- Due to success client has selected ARC coatings as “patch repair” for all tile-lined chutes and lines
