Challenge

Customer was considering replacing lower section of stack liner due to severe flue gas induced corrosion. Replacement cost and unscheduled downtime was estimated at \$500K.

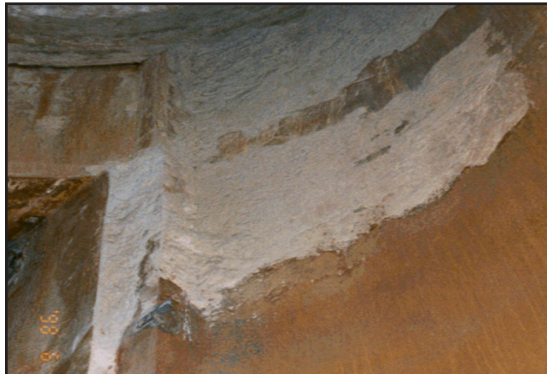
Condensing flue gas was generating corrosive acid concentrations on unprotected steel.

Severe corrosion inside the stack

- Mechanical removal of scale and corrosion with scrapers
- Power wash to remove invisible salts in metal
- Grit blast to Sa 2.5 with 3 mil (75 µm) angular profile

1. Apply **ARC S7** stripe coat to weld seams
2. Apply 2 coats of **ARC S7**, total ~DFT: 40 mils (1.0 mm)

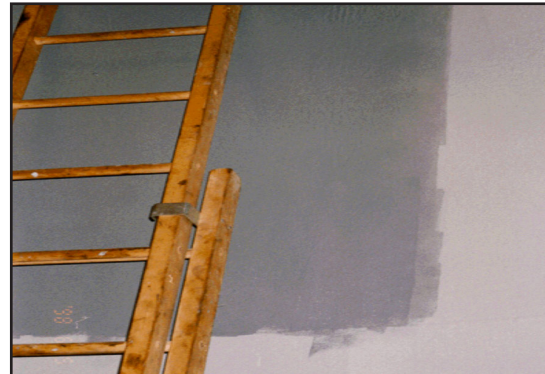
First coat of ARC S7

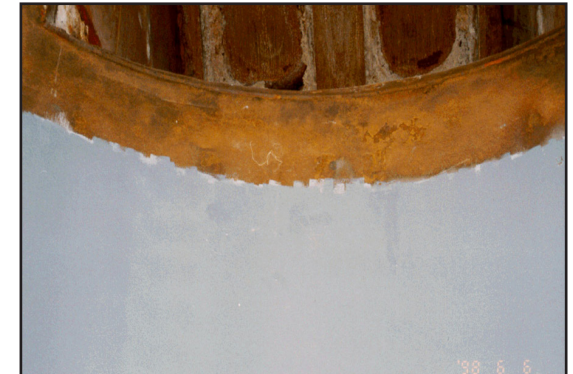
Second coat of ARC S7 applied, completing the project
