Issue

Sever pitting corrosion in tank floor and heavy corrosion scale created suspended particles that clog cooling system requiring frequent and costly clean outs. A new tank was purchased after 6 years.

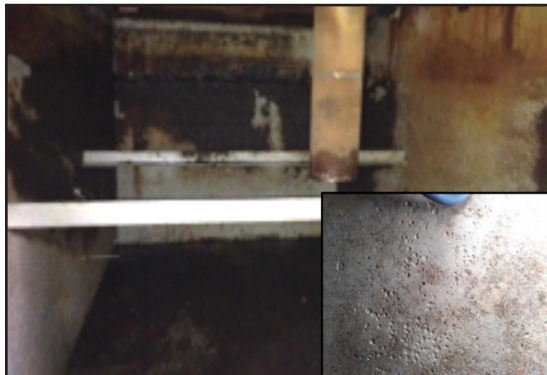
Glycol and water based coolant corrode carbon steel tank.

Heavy pitting corrosion in glycol water tank

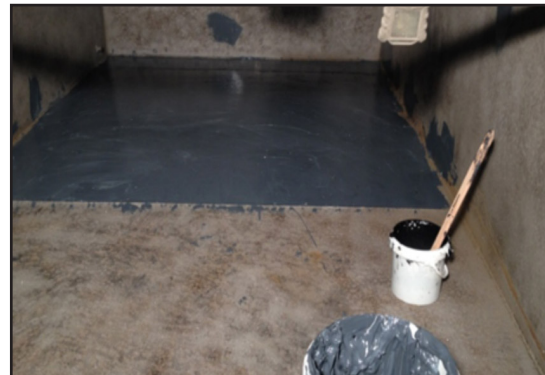
Applying ARC 858 to resurface and fare smooth pitted surface

- Grit blast to Sa 2.5 with 3 mil (75 µm) angular profile

1. Apply **ARC 858** to entire floor and weld seams to fill pitted regions
2. Two coats of **ARC S7** applied as chemically resistant topcoat

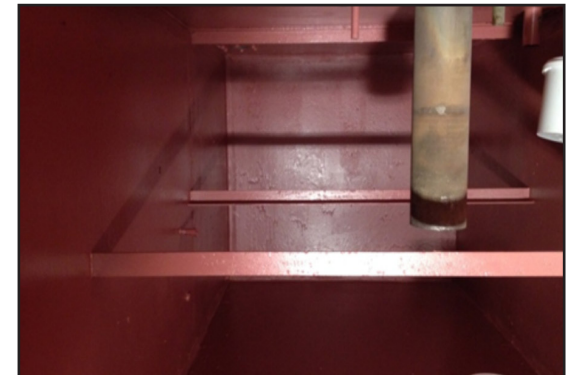
Completed tank internals
