Challenge

Issue

Loss of ceramic tile results in abrasion and corrosion damage to structural steel requiring weld patching every 12-14 days. Maintenance shut downs (12 hrs) allow for partial patching.

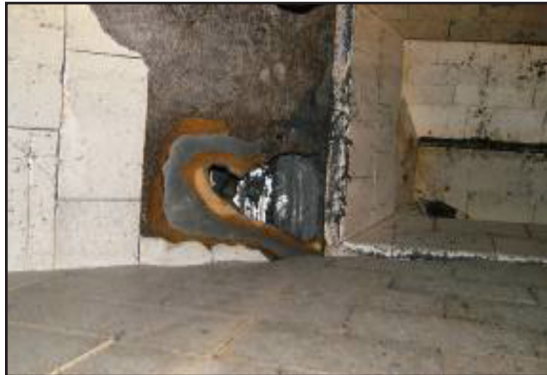
Failure of brittle ceramic tiles due to impact of coal particles as large as 4" (10 cm) diameter.

Failure of tile lined chute after 4 months prior to patch weld

- Exposed metal was patch welded
- Grit blast to Sa 2.5 with 3 mil (75 µm) angular profile

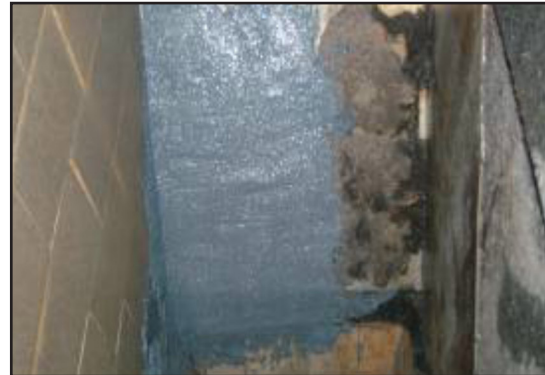
Application of ARC MX5

1. Apply **ARC MX5** @ 120-200 mil (3-5 mm) to steel and butting up to ceramic tile
2. Total repair was completed in <12 hours

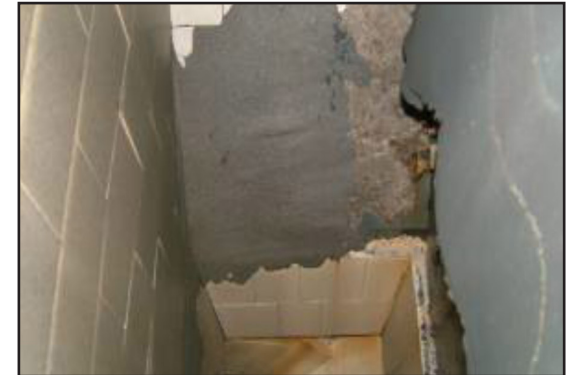
| ■ Life of ARC MX5 repair: | >7 months |

ARC MX5 after 7 months
