Exposed aggregate in sand filter was promoting algae growth leading to increased vessel draining and cleaning

- Seal surface and apply coating to reduce algae growth

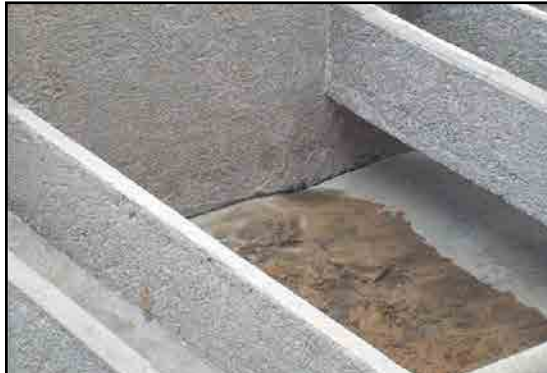
Exposed aggregate promotes algae retention

Drained sand filter vessel

- Surfaces grit blasted to CSP3 finish

- Skim coat of cementitious mortar applied to resurface concrete
- Two coats of **ARC S1PW** applied at 15-20 mil (375-500 µm) in alternating colors

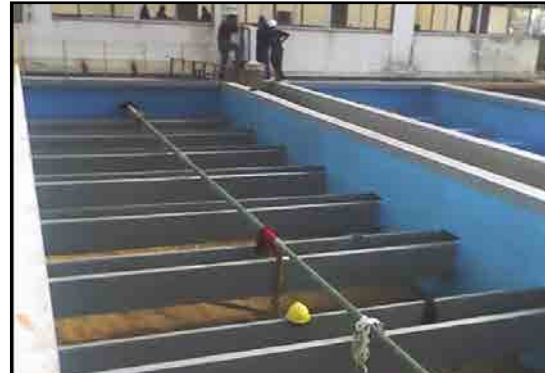
Installing ARC S1PW coating

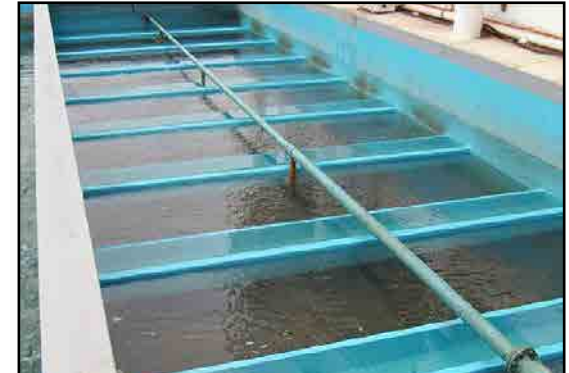
- Vessel has been in continuous service for over 7 years
- Algae cleaning can be easily done with low pressure hoses

Cleaning time reduced from 2-month to 3-year saving over 200 man-hours per year

Sand filter in service
