## Challenge

Failing tile liner and delamination of underlying concrete was contaminating stock product. Outage for repairs was only 72 hours

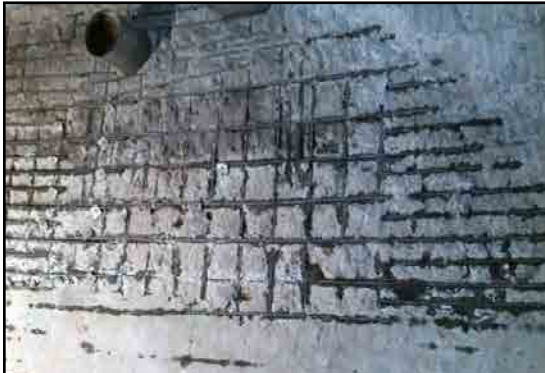
Chest wall after tile removed and blasted

- Old tile removed, then concrete rebar surfaces abrasive grit blasted to CSP 3/CSP 5 finish

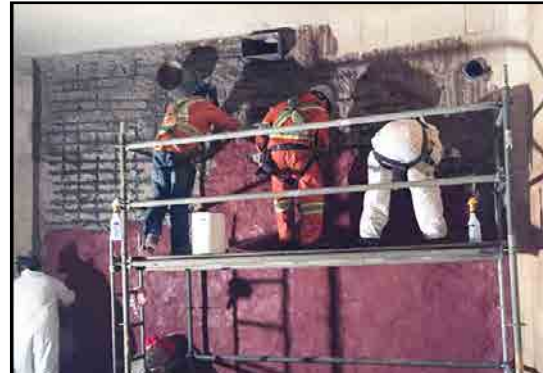
Installing ARC NVE coating

- **ARC NVE Primer** applied followed by 3 coats of **ARC NVE Top Coat** at 120-200 mil (3-5 mm)/coat. Total DFT 360-600 mil (9-12.5 mm)
- Final veil coat of **ARC NVE VC** applied at 15-20 mil (375-500 µm)

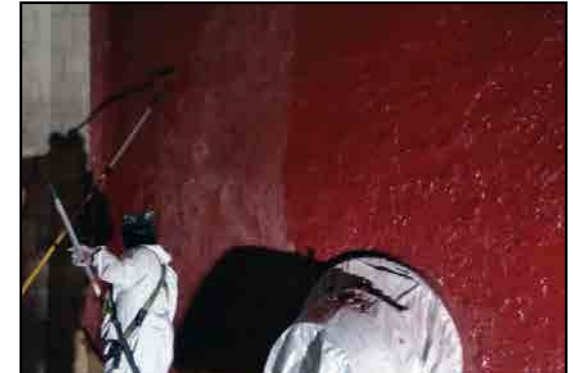
Applying NVE sealer coat
