## Challenge

Rubber liner in discharge chute that connects ball mill discharge hopper to slurry pump is wearing exposing metal to abrasion.

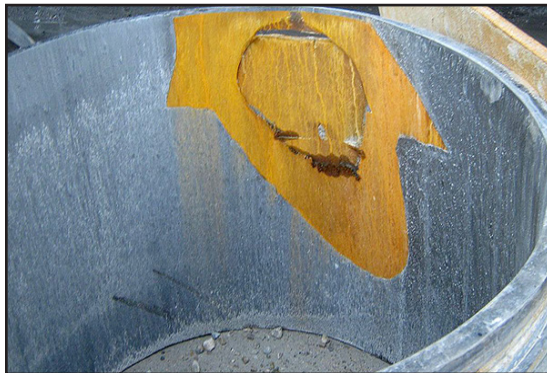
External metal patch welded on chute to extend MTBR.

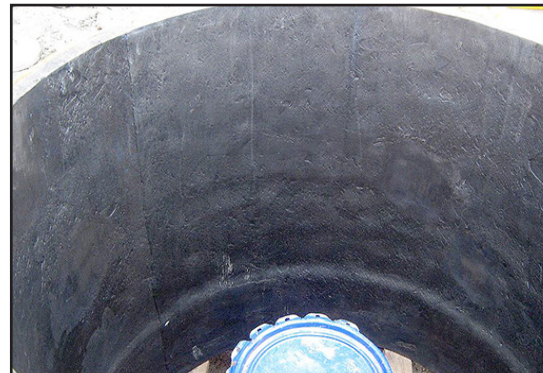
Rubber surface is prepared by roughening with flapper wheel.

- Clean surface from dust and particles
- Flapper wheel to Sa 2.5 with 2 mil (50 µm) angular profile on metal, and to roughen rubber lining surface.

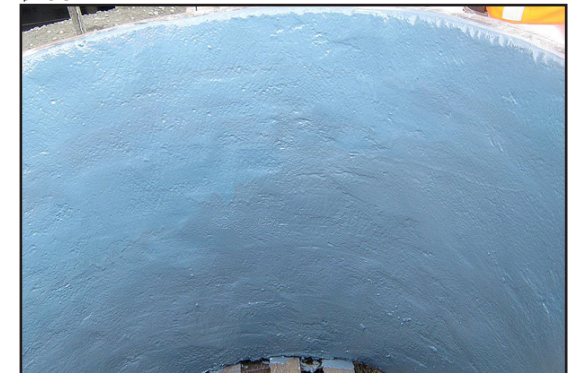
Chute protected with ARC BX1 over rubber and worn metal.

1. Apply **ARC BX1** to complete internal surface at a thickness of >500 mil (12.5 mm)

- ARC-coated chutes have extended MTBR to more than 3X that of rubber lined
