Challenge

Highly corrosive environment from flotation reagents was affecting moly process tank structure and wall thickness to a critical stage.

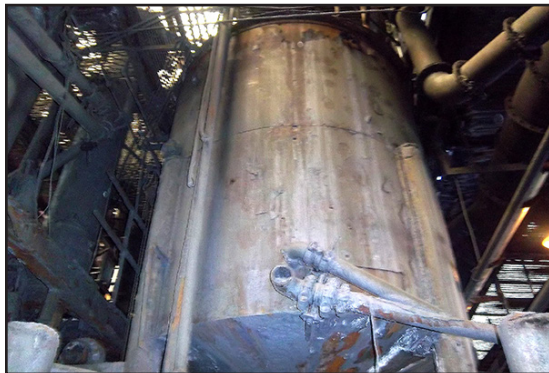
Chemicals related to molybdenum flotation process (reagents) added to high temperature fluid (60°C - 140°F) also affected by dissimilar metals. Tank had not been previously lined.

Tank in operation in highly corrosive environment

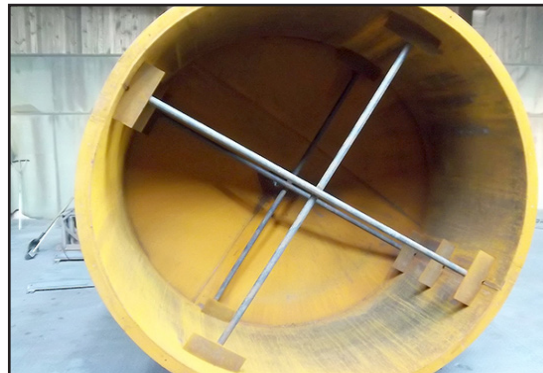
Tank bottom half ready for surface preparation

- Grit blast to Sa 2.5 with 3 mil (75 µm) angular profile

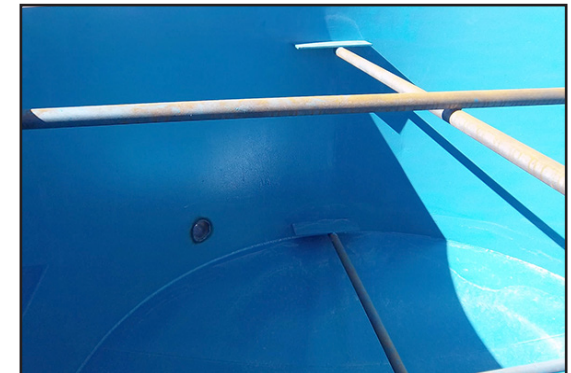
Tank bottom half after application of 2 coats of ARC SD4i

- Apply two alternating color coats of **ARC SD4i** to all internal surfaces @ total DFT of 20 mil (500 µm)
- External protection with high % solids urethane paint

- Total cost of ARC coating only: **\$ 5,200**
- New tank installed in Sept. 2011
- To date, the tank has no corrosion issues
- Expected functional life of tank: well over 8 years
