Challenge

H₂S gas damaged the concrete in a wet well and sludge tanks leading to loss of coverage and dislodgement of the aggregate.

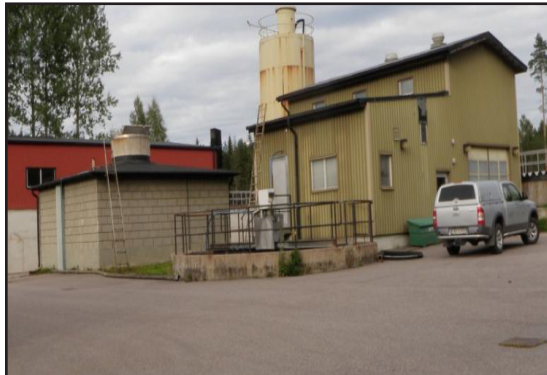
Hydrogen sulfide gases from micro-biological corrosion caused damage to concrete.

Wet well location.

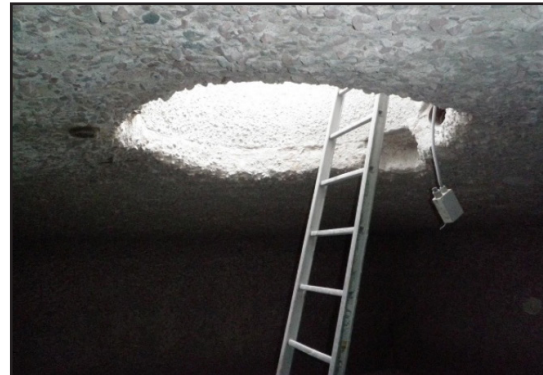
Surface of wet well was high pressure cleaned and abrasive sweep sandblasted.

- Surface was high-pressure water blasted and verified to have pH between 7 – 10.
- Surface was sweep sandblasted to ICRI CSP#3 finish

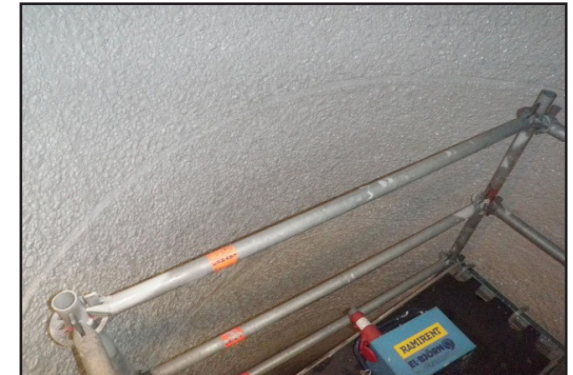
Surface of the wet well with final coat of **ARC S1HB**.

- **ARC S1HB** was applied in one single coat system application to a final wet film thickness of >3 mm (120 mils)

- Lining was installed in three separate structures over an eight-day period.
- After more than six years, no signs of further concrete loss have been noted during inspections.
