Challenge

- Eliminate “slip and fall” safety issues on corrosion damaged concrete scraper conveyor floor
- Reduce efficiency impact damage

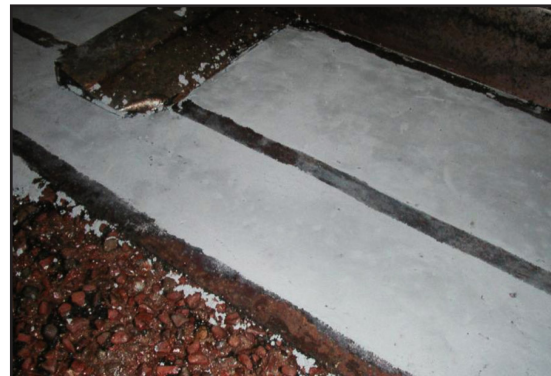
Rebuilding with ARC 791

1. Prime using **ARC 797** to promote adhesion
2. Topcoat with **ARC 791** to perform under load against sliding abrasion and chemical attack

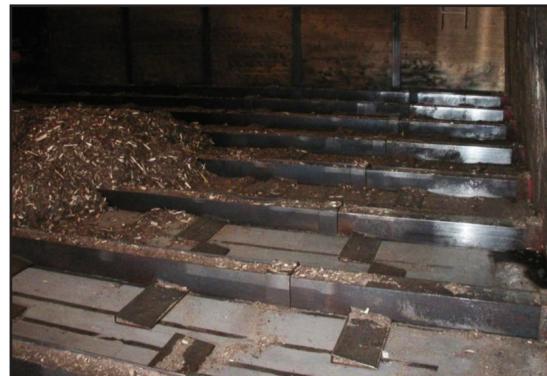
After 3 year inspection, the application is in perfect condition
