## Challenge

Paint from paper machine frame peels off and effects production quality of white Kraft paper requiring repainting of machine frame every 12-18 months.

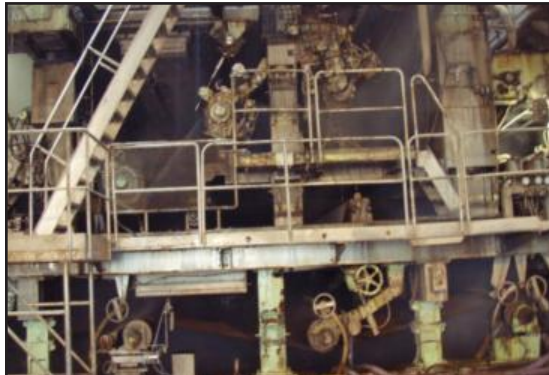
Constant surface exposure to water, chemicals, vapors, and high temperature effects protective coating and leads to delamination.

Corroded structure of old paper machine

- High pressure water wash to remove old coating
- Grit blast to Sa 2.5 and 3 mil (75 µm) angular profile

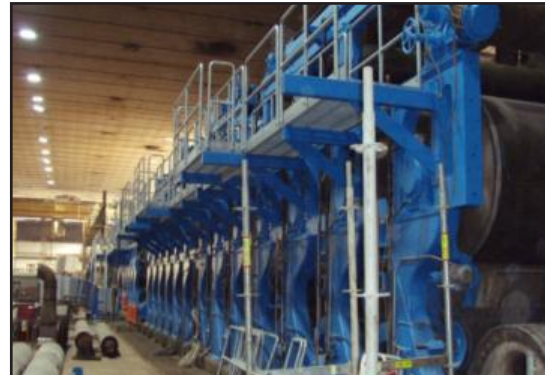
ARC S1PW applied to frame during refurbishment

1. Apply two coats of **ARC S1PW** in alternating colors with @ 20-25 mils (500-630 µm) total DFT

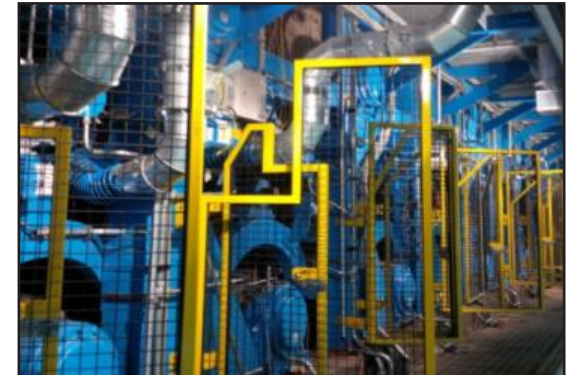
- Life of ARC solution exceeds >7 years (4.5X previous coating)
- Eliminated production losses
- Halted machine frame corrosion

PM7 structure coated with ARC S1PW
