Challenge

Issue: Ultra high-pressure water blasting is required every 6–12 months to remove mineral scale buildup. This periodic blasting damages protective lining leading to reduced equipment availability.

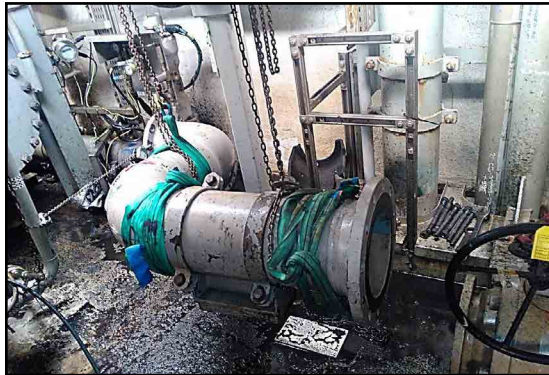
Root Cause: At elevated temperatures mineral solids lead to scale formation on internal surfaces, thus reducing flow and production rates.

Pool sections

All surfaces were low-pressure water blasted with demineralized water to remove soluble salts, followed by grit blasting to Sa 2.5 cleanliness with profile of 3+ mil (75+ μm).

ARC S5 was applied in a single coat at 20–25 mils (508– 635 μm) and allowed to cure for two days at 25°C (77°F) prior to being put back into service.

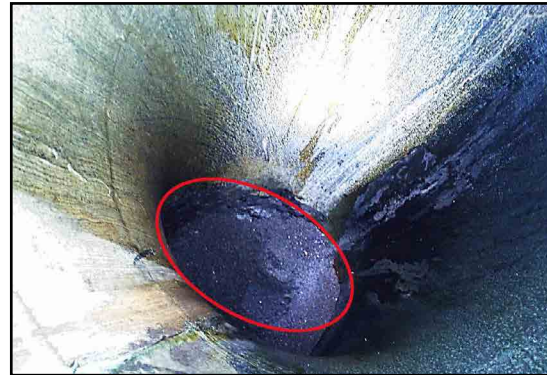
Dark scale formation on unlined section

After 27 months in service, the unlined sections of the spool showed signs of corrosion and scale buildup requiring UHPW blasting.

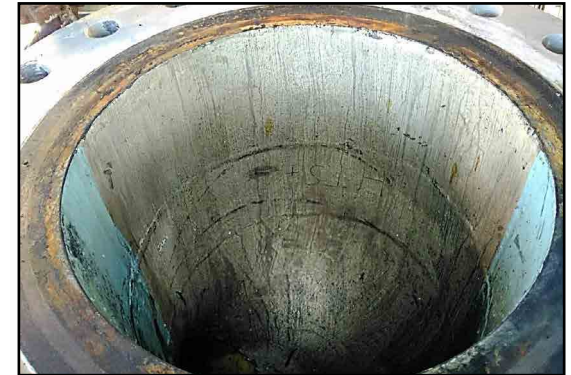
Sections coated with **ARC S5** showed no signs of corrosion, and the minimal scale present could be easily removed with a rag or low-pressure water blasting.

ARC S5 prevented corrosion and scale formation after 27 months
